# THE VERMONT HOME INSPECTION COMPANY LLC

## THE VERMONT HOME INSPECTION COMPANY LLC COPY

1 Satisfied Client Lane  
Wilmington, VT 05363

AUGUST 23, 2022

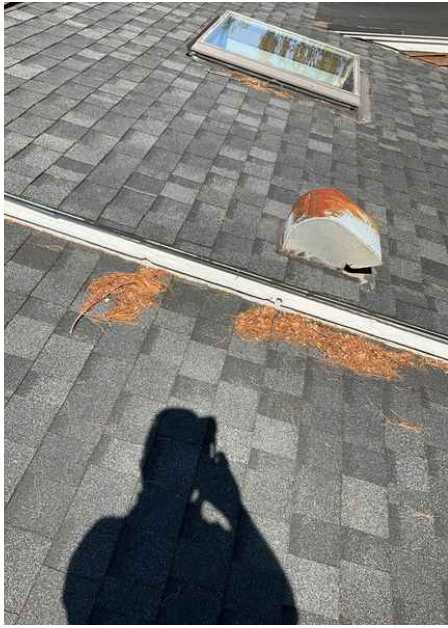
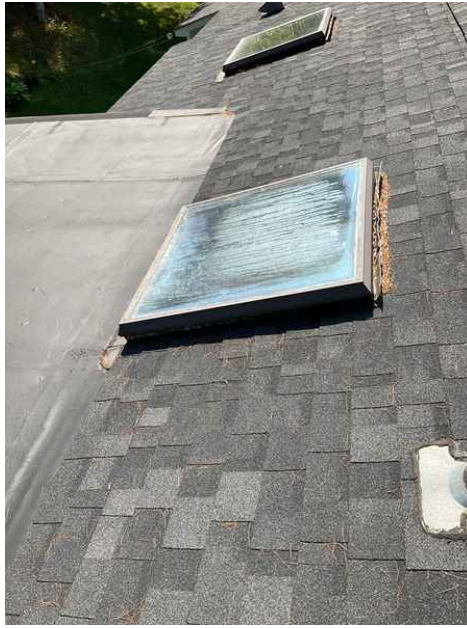
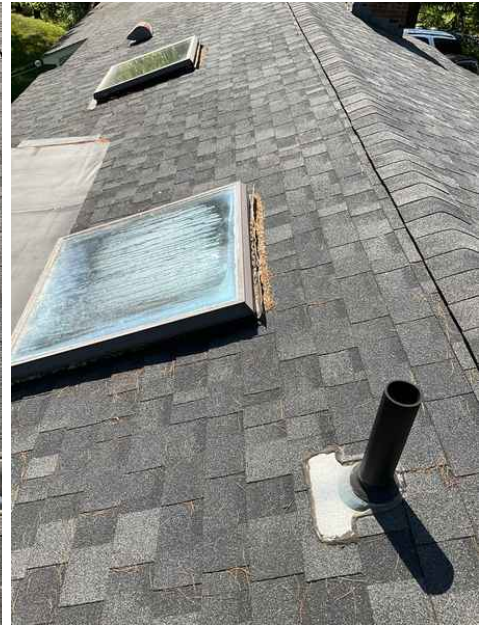
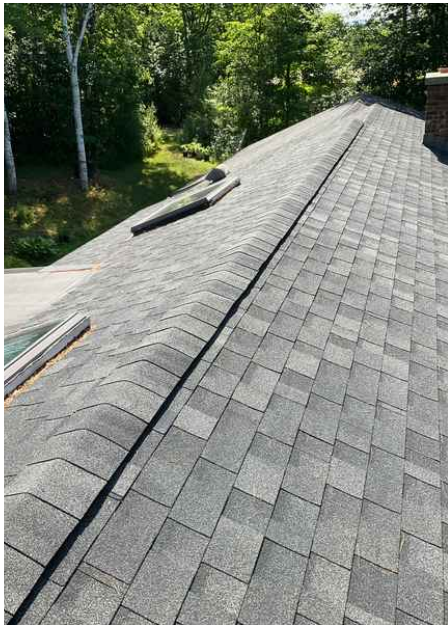
**Roof Covering: Roof**

I was able to go on the roof to inspect it. The roof is newer and looks great, just need to watch for pine needles and branches that may build up around the chimney and skylights.

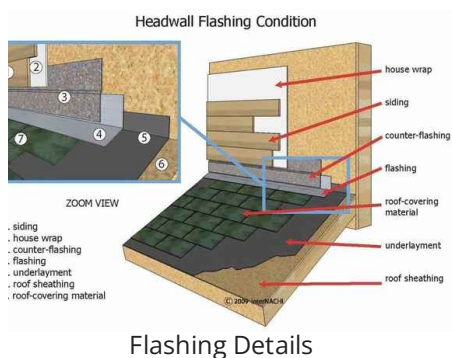
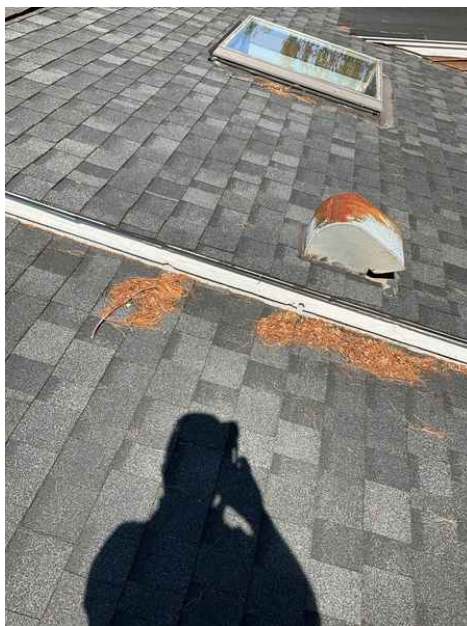
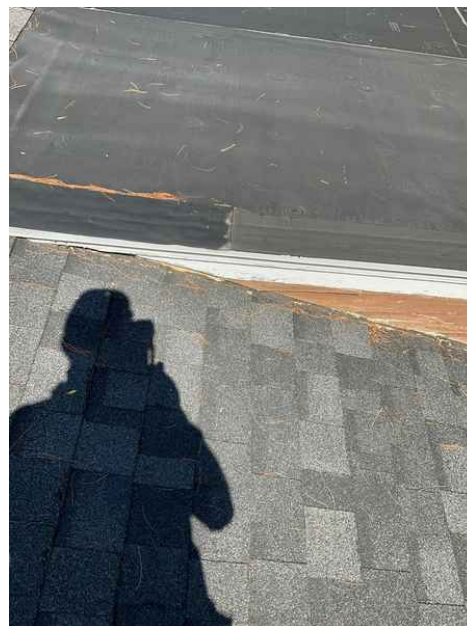
## Flashing: Wall Intersections

I looked for flashing where the roof covering meets a wall or siding material. There was step and counter flashing installed in these locations. This is not an exhaustive inspection of all flashing areas.

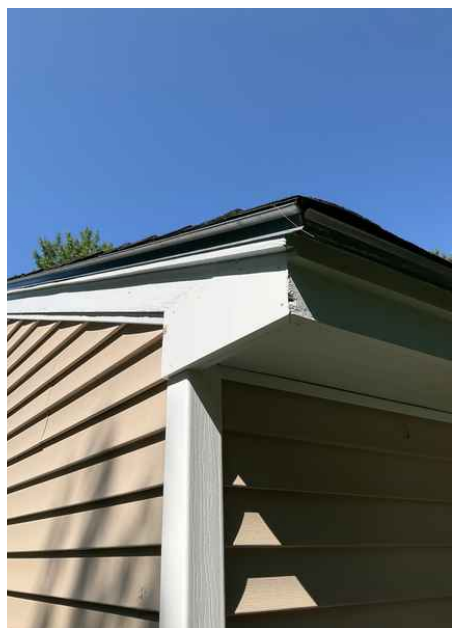
## Flashing: Eaves and Gables

I looked for flashing installed at the eaves (near the gutter edge) and at the gables (the diagonal edge of the roof). There was metal drip flashing material installed in these locations. The flashing helps the surface water on the roof to discharge into the gutter. Flashing also helps to prevent water intrusion under the roof-covering.

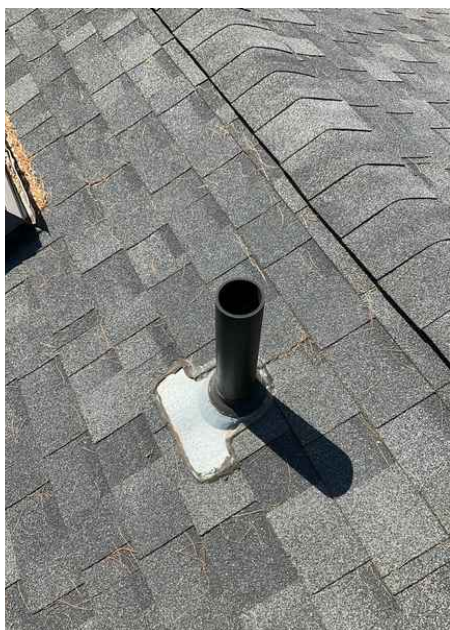
## Plumbing Vent Pipes: Plumbing Vent Pipes Inspected

The vent pipe appeared to have proper flashing.

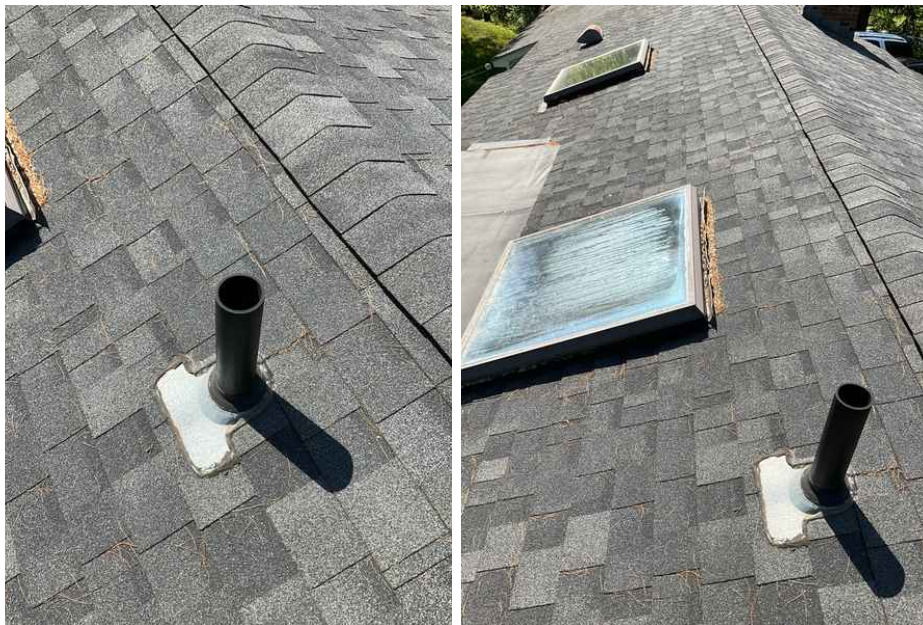
## Plumbing Vent Pipes: Vent pipe

Vent pipe looks good

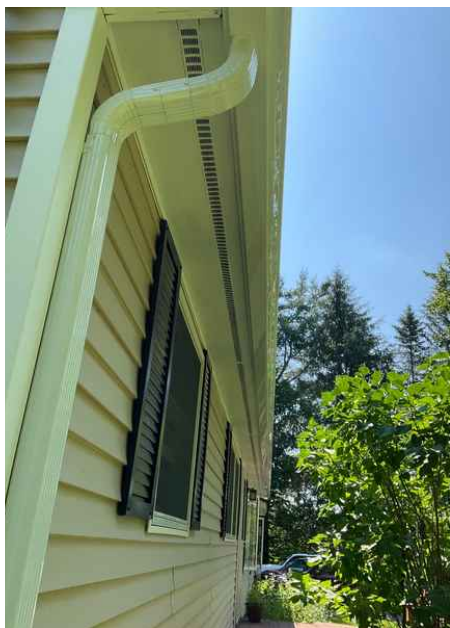
There were gutters on the front side of the house, none on the back. If water infiltration occurs along the back or side walls of the basement, the addition of gutters may be an affordable solution.

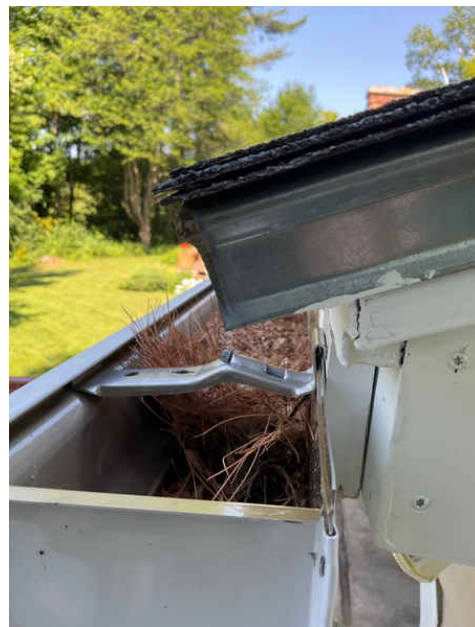
## 2.4.1 Gutters &amp; Downspouts

I observed debris in the gutter. Cleaning and maintenance is recommended.

Contact a qualified gutter contractor

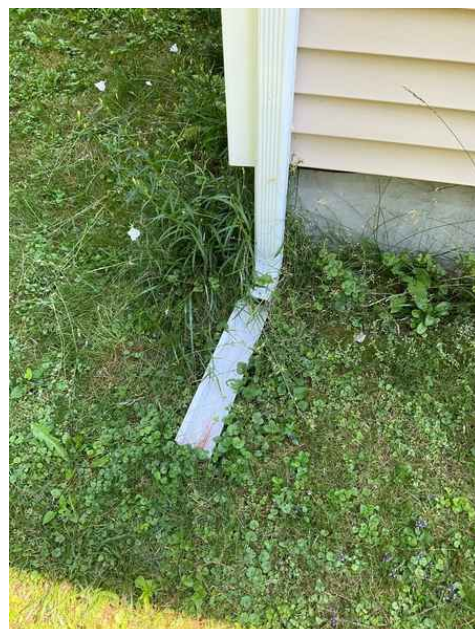
## 2.4.2 Gutters &amp; Downspouts

**DOWNSPOUTS DRAIN NEAR HOUSE**

One or more downspouts drain too close to the home's foundation.

This can result in excessive moisture in the soil at the foundation, which can lead to foundation/structural movement. Recommend a qualified contractor adjust downspout extensions to drain at least 6 feet from the foundation. A handy homeowner should be able to do this project.

Recommended DIY Project

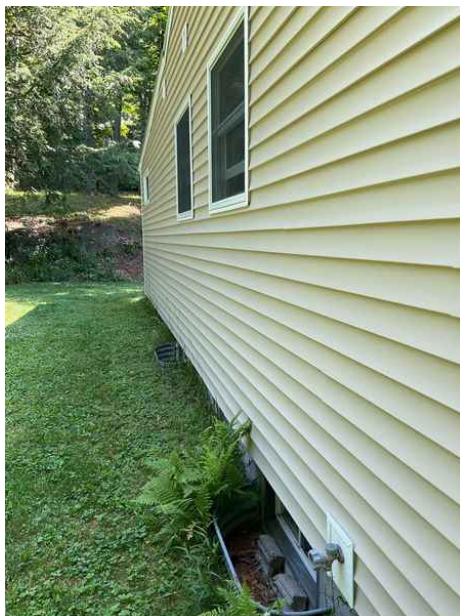
#### Wall-Covering, Flashing & Trim: Siding

The siding appears to be relatively new and in good shape

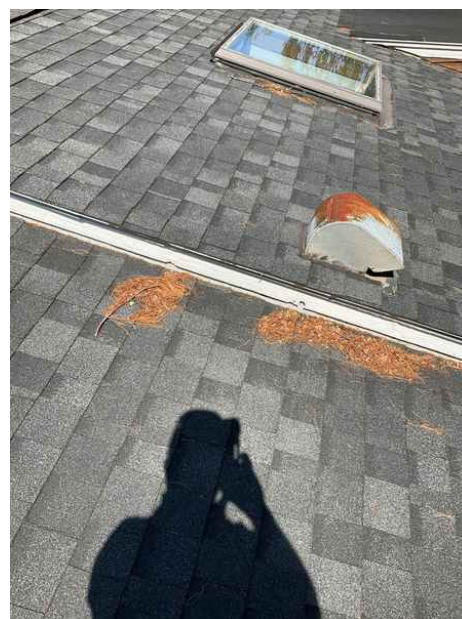
#### Exhaust Hoods: Exhaust hood Roof and gable ends

Exhaust hood appears to be in good shape.

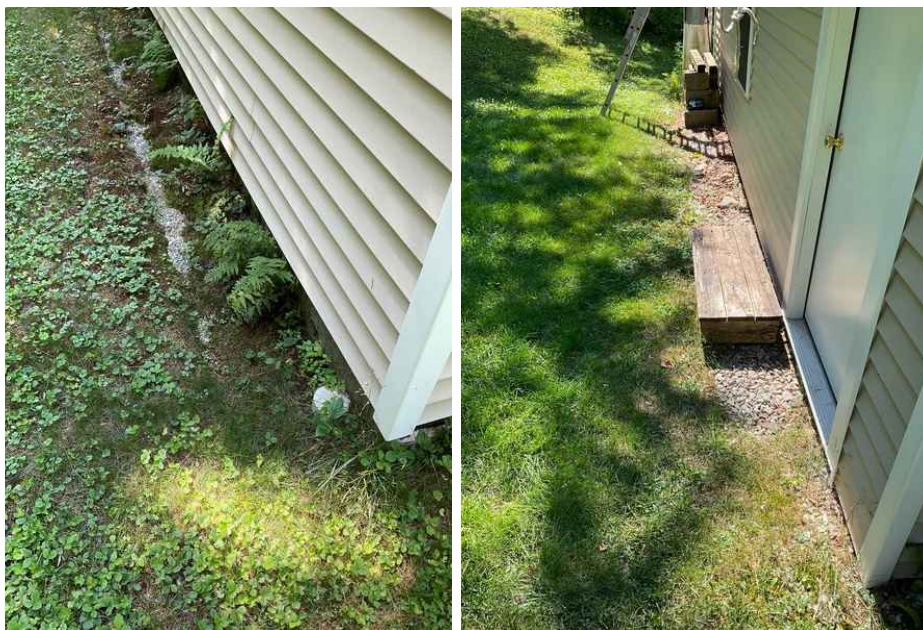
**Vegetation, Surface Drainage, Retaining Walls & Grading: Surface drain**

Along the back of the house there's what appears to be a surface drain / French drain. I'm not sure where that drain exits too, but it's good to have that drain in place.

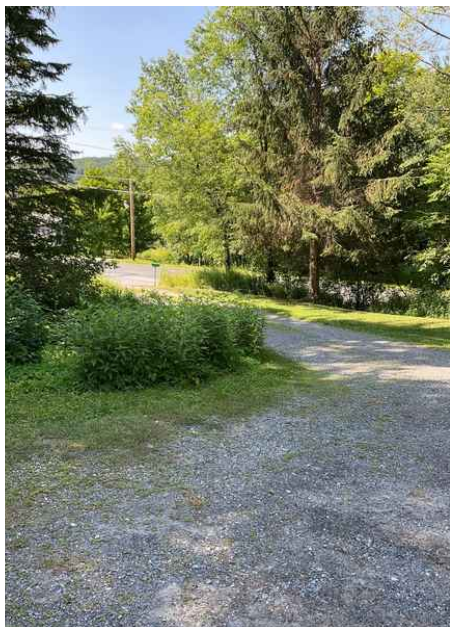
**Walkways & Driveways: Walkways & Driveways Were Inspected**

I inspected the walkways and driveways that were adjacent to the house. All appeared to be in acceptable condition.

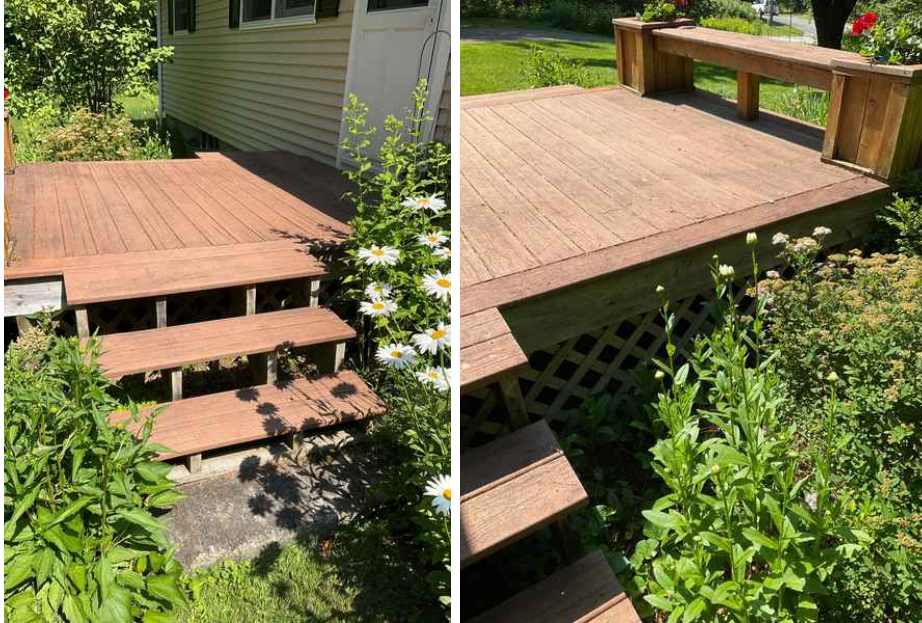
All treads should be level and secure. Riser heights and tread depths should be as uniform as possible. As a guide, stairs must have a maximum riser of 7-3/4 inches and a minimum tread of 10 inches. The stairs were built within that standard.

The height of the front deck was 29".

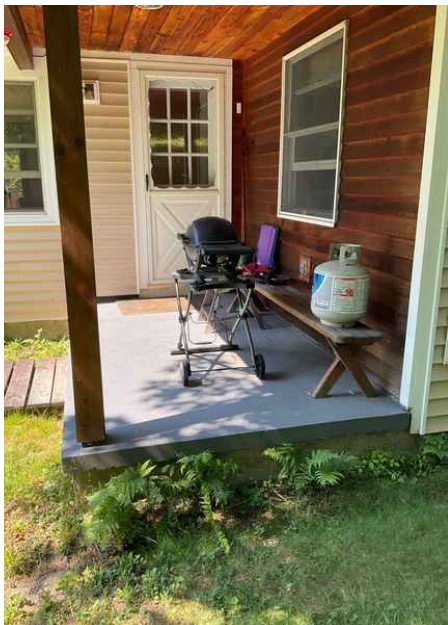
**Porches, Patios, Decks, Balconies & Carports: Porches, Patios, Decks, Balconies & Carports Were Inspected**

I inspected the porches, patios, decks, balconies and carports at the house that were within the scope of the home inspection.

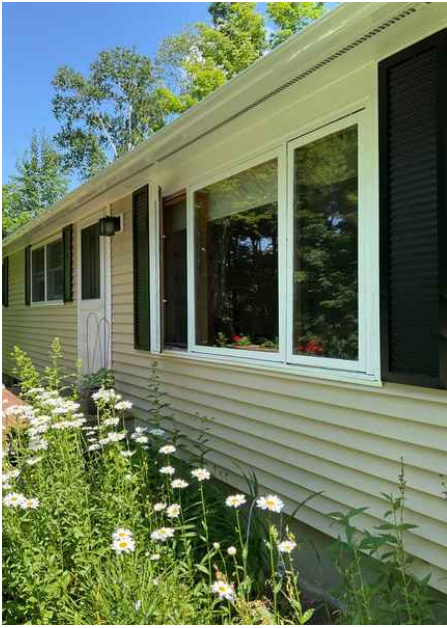
**Windows: Windows Inspected**

A representative number of windows from the ground surface was inspected. Mostly vinyl windows appear to be in good shape, Andersen Windows with wood interiors.

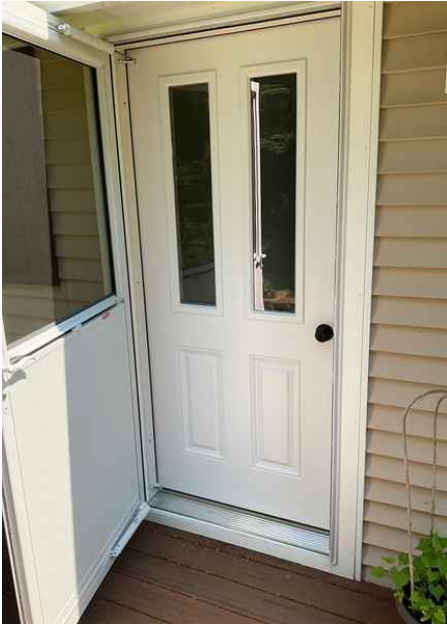
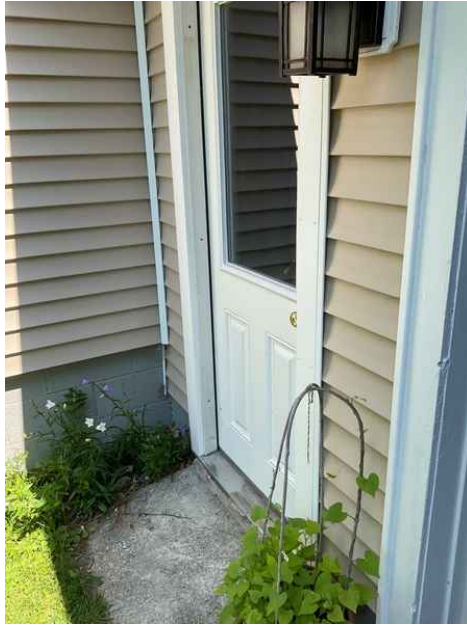
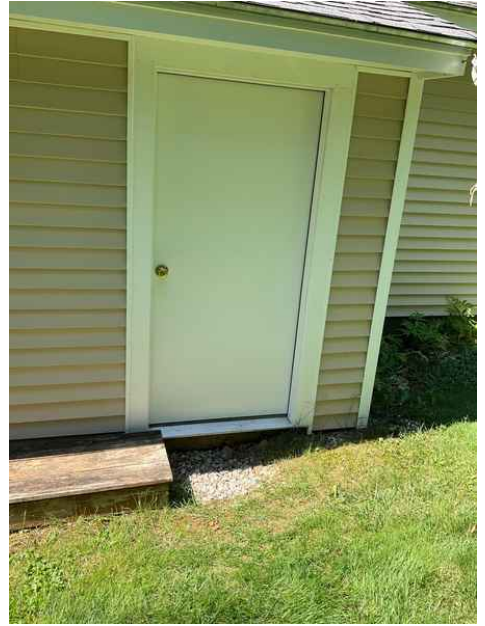
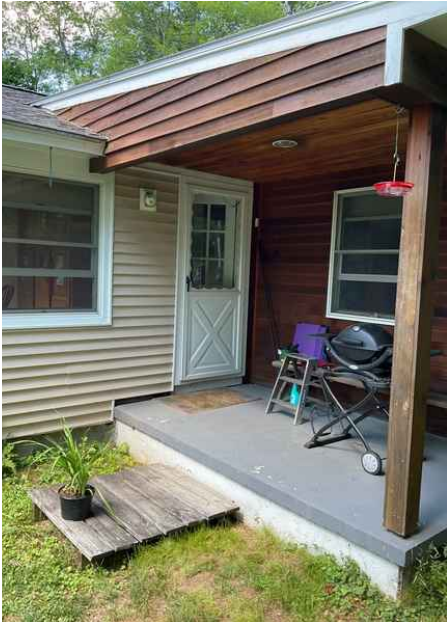
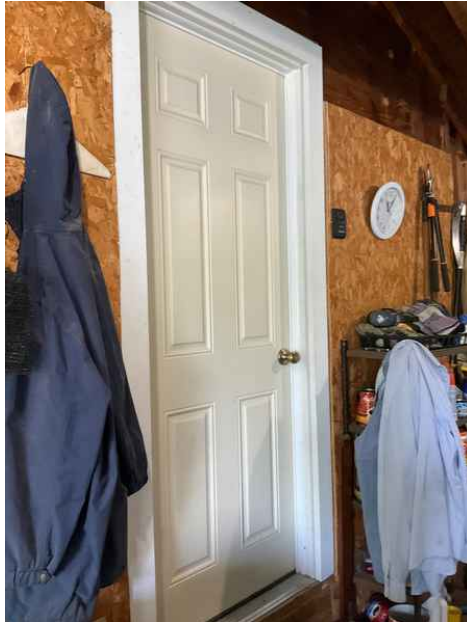
## Exterior Doors: Exterior Doors Inspected

I inspected the exterior doors. All were inspected for operation and weather tightness, there were no apparent defects.

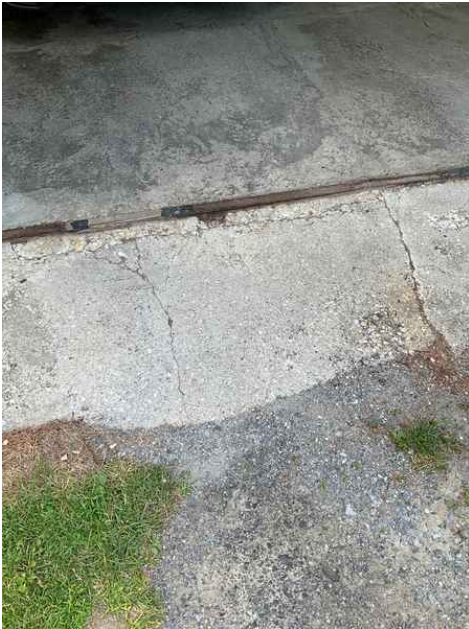
### **RAMP TO GARAGE**

Observed some cracking on the ramp to the garage

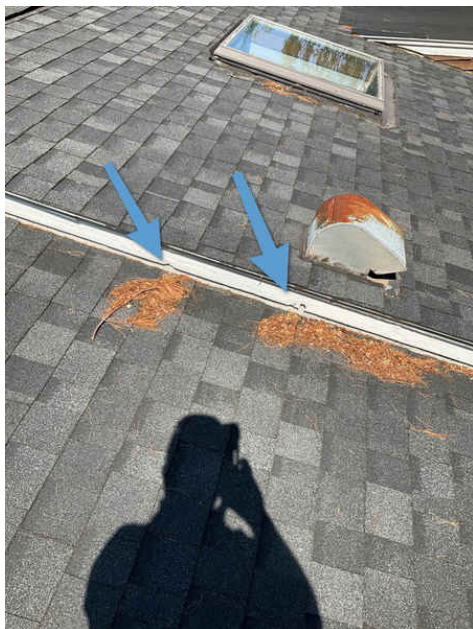
### 3.2.1 Eaves, Soffits & Fascia

#### DAMAGE OBSERVED AT EAVES

I observed indications that one or more areas of the eaves were damaged.

The gable trim boards at the different levels of roof require painting or possible replacement.

Correction and further evaluation is recommended.

Contact a qualified handyman.

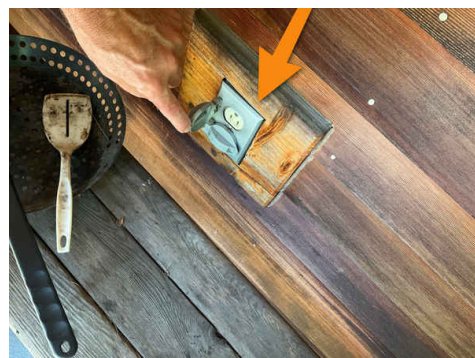
## 3.5.1 GFCIs &amp; Electrical

**MISSING GFCI**

I observed that a GFCI is missing in an area that is required to keep people safe.

Major Defect

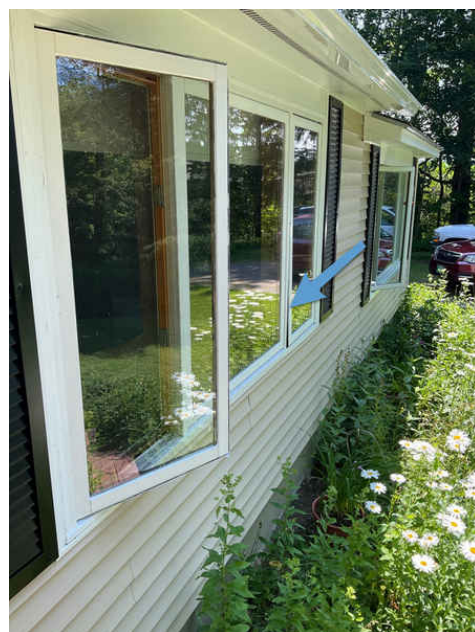
## 3.10.1 Windows

**WEATHERSTRIP**

Minor Defect

## Repair or replace

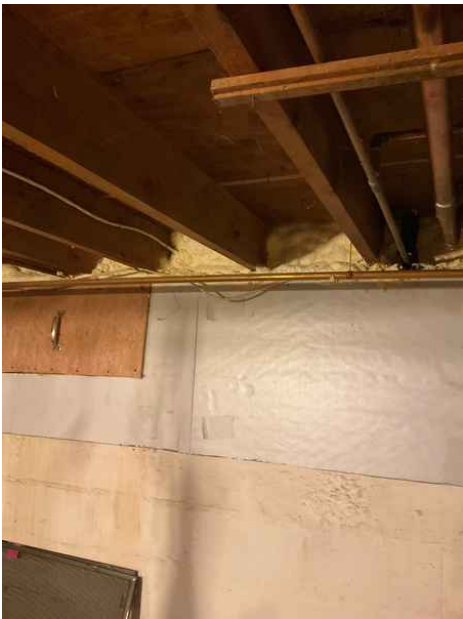
**Sump Pump: No Sump Pump**  
The house doesn't have a sump pump

**Insulation in Foundation/Basement Area: Type of Insulation Observed**  
Between joists in the basement.  
Spray Foam

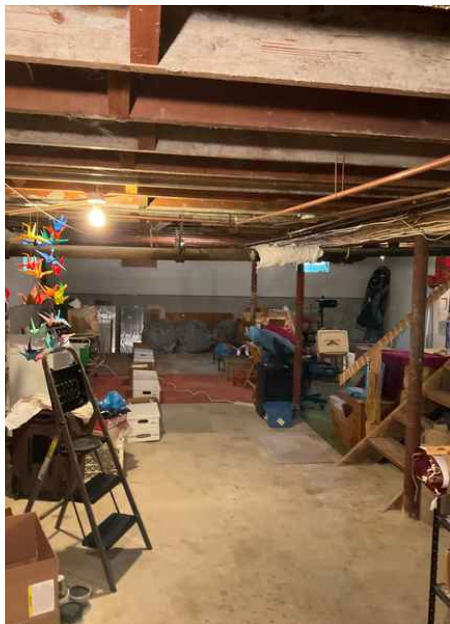
The basement was inspected according to the [Home Inspection Standards of Practice](#).

The basement can be a revealing area in the house and often provides a general picture of how the entire structure works. In most basements, the structure is exposed overhead, as are the HVAC distribution system, plumbing supply and DWV lines, and the electrical branch-circuit wiring. I inspected those systems and components.

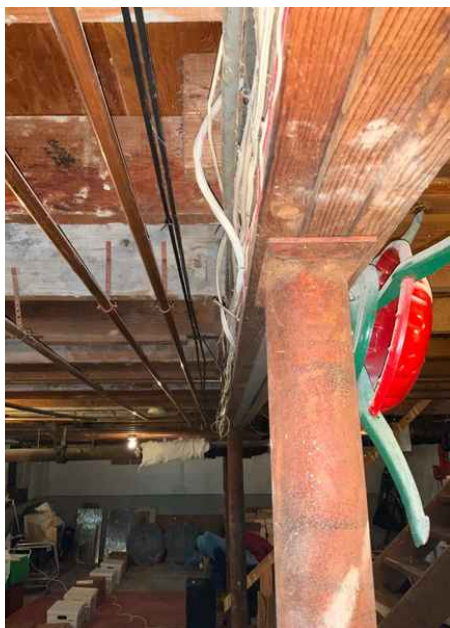
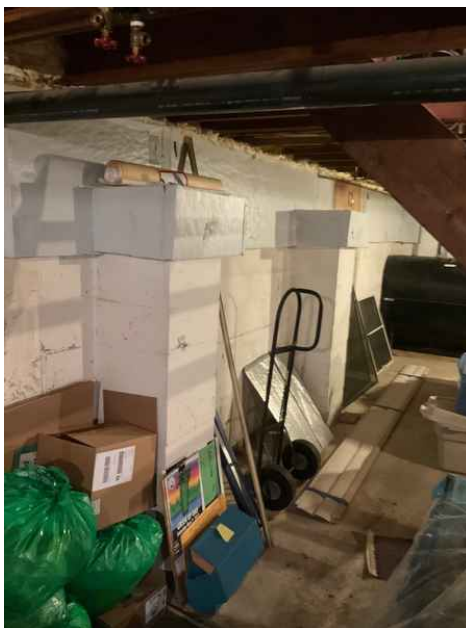
## Basement: Structural Components Were Inspected

Structural components were inspected according to the [Home Inspection Standards of Practice](#), including readily observable floor joists.

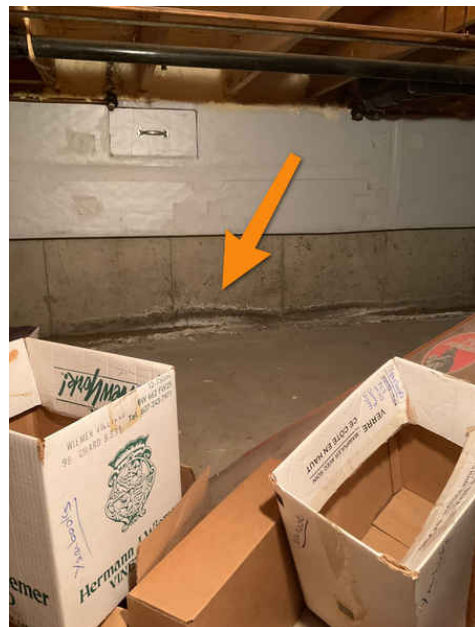
### **EFFLORESCENCE OBSERVED**

FOUNDATION CRAWL SPACE.

I observed efflorescence.

Efflorescence is the white chalky powder that you might find on the surface of a concrete or brick wall. It can be a cosmetic issue, or it can be an indication of moisture intrusion that could lead to major structural and indoor air quality issues.

I noted the presence of efflorescence in the inspection report because it generally occurs where there is excess moisture, a condition that also encourages the growth of mold.

Contact a qualified professional.

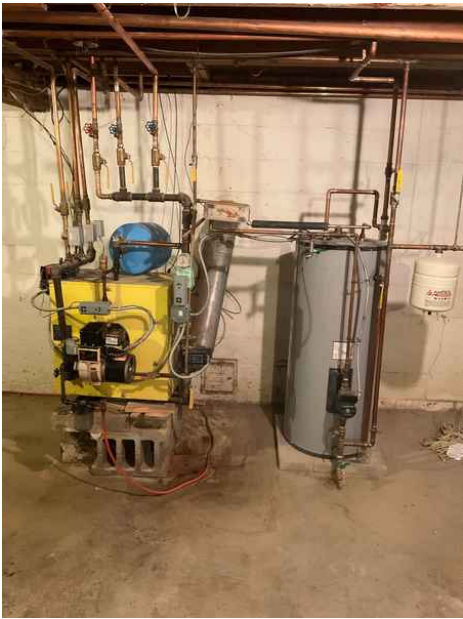
<b>Heating System Information:</b> <b>Energy Source</b> Oil	<b>Heating System Information:</b> <b>Heating Method</b> Basement Hot-Water Heating System  The unit was running during the inspection.	<b>Thermostat and Normal Operating Controls: Thermostat Location</b> First floor, Multiple locations
---	--	---

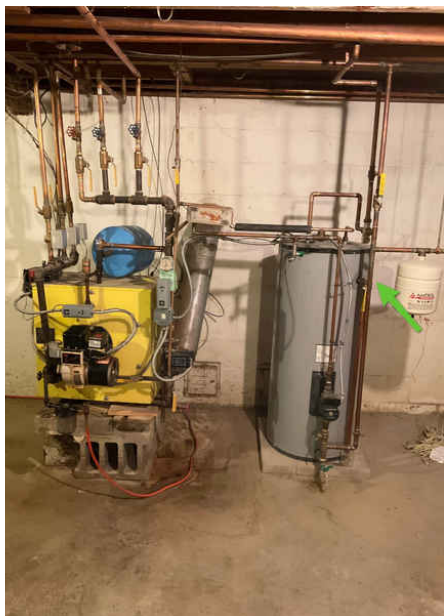
#### Hot Water Source: Inspected TPR Valve

I inspected the temperature and pressure relief valve.

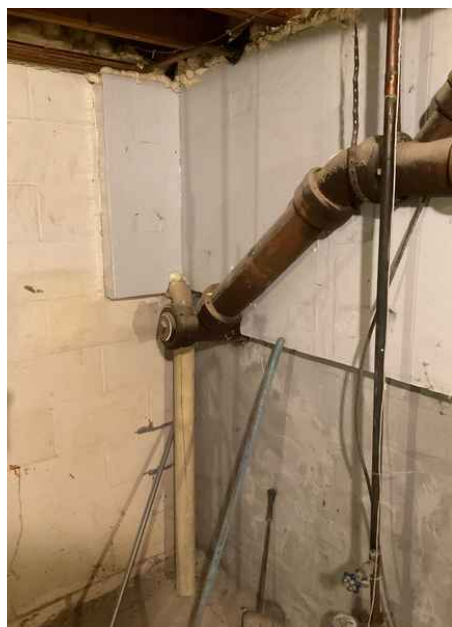
I attempted to inspect the drain, waste, and vent pipes. Not all of the pipes and components were accessible and observed. Inspection restriction. Ask the homeowner about water and sewer leaks or blockages in the past.

Public Sewer

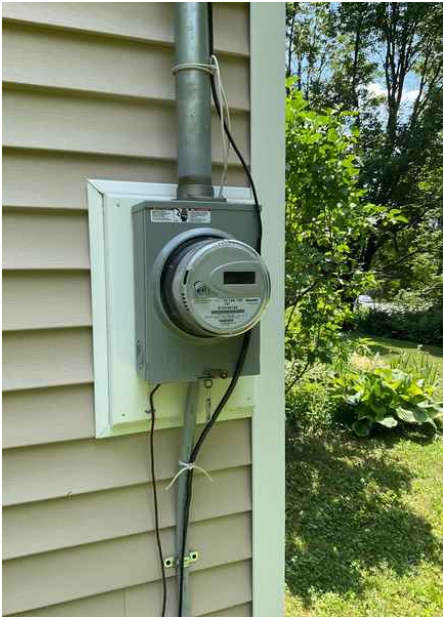
**Electrical Wiring: Type of Wiring, If Visible**

NM-B (Romex)

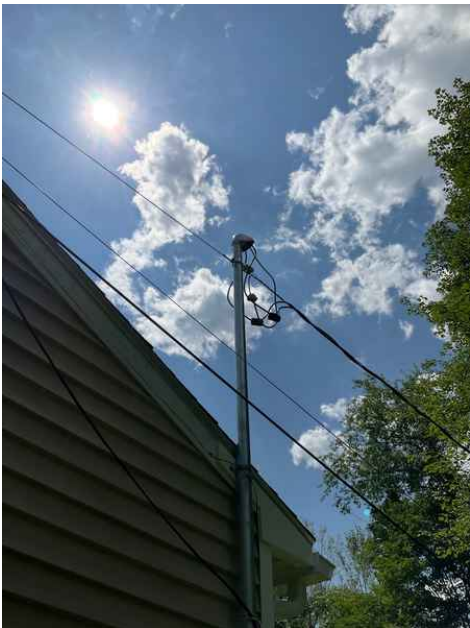
**Service-Entrance Conductors: Inspected Service-Entrance Conductors**

Front of house

I inspected the electrical service-entrance conductors.

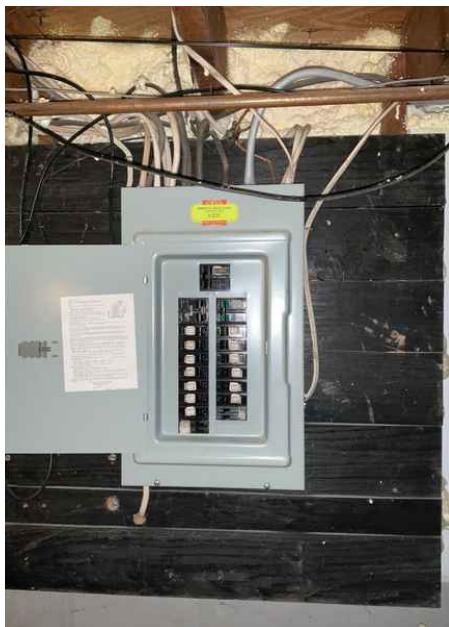
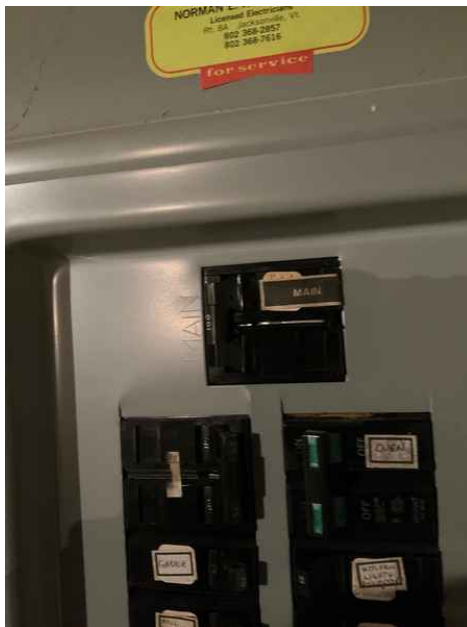
Basement, streetside to the right

I inspected the electrical main service disconnect.

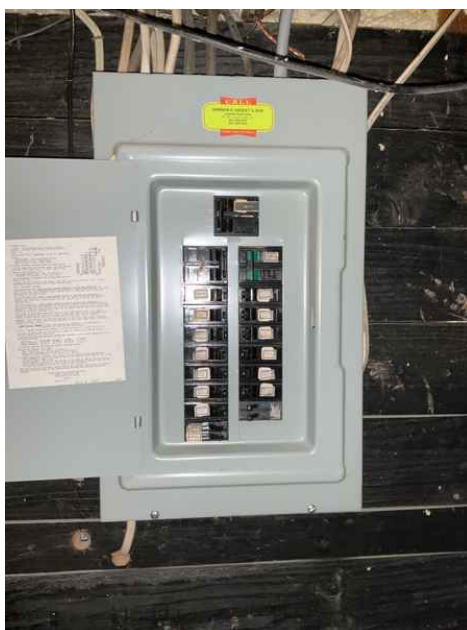
## Panelboards & Breakers: Inspected Main Panelboard & Breakers

I inspected the electrical panelboards and over-current protection devices (circuit breakers and fuses).

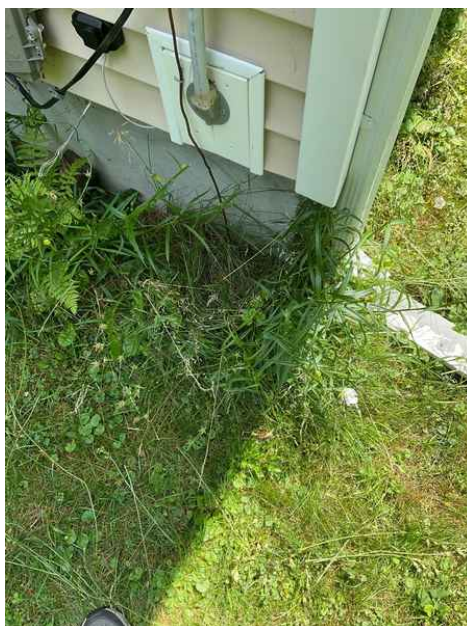
## Service Grounding & Bonding: Inspected the Service Grounding & Bonding

I inspected the electrical service grounding and bonding.

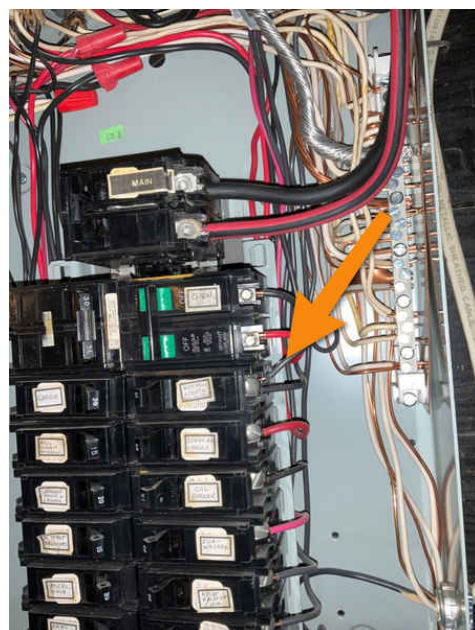
## 8.5.2 Panelboards &amp; Breakers

**DOUBLED HOT CONDUCTORS**

Major Defect
